NIST NCSTAR 1-5A

Federal Building and Fire Safety Investigation of the World Trade Center Disaster

Visual Evidence, Damage Estimates, And Timeline Analysis

(Chapter 9 - Appendix C)

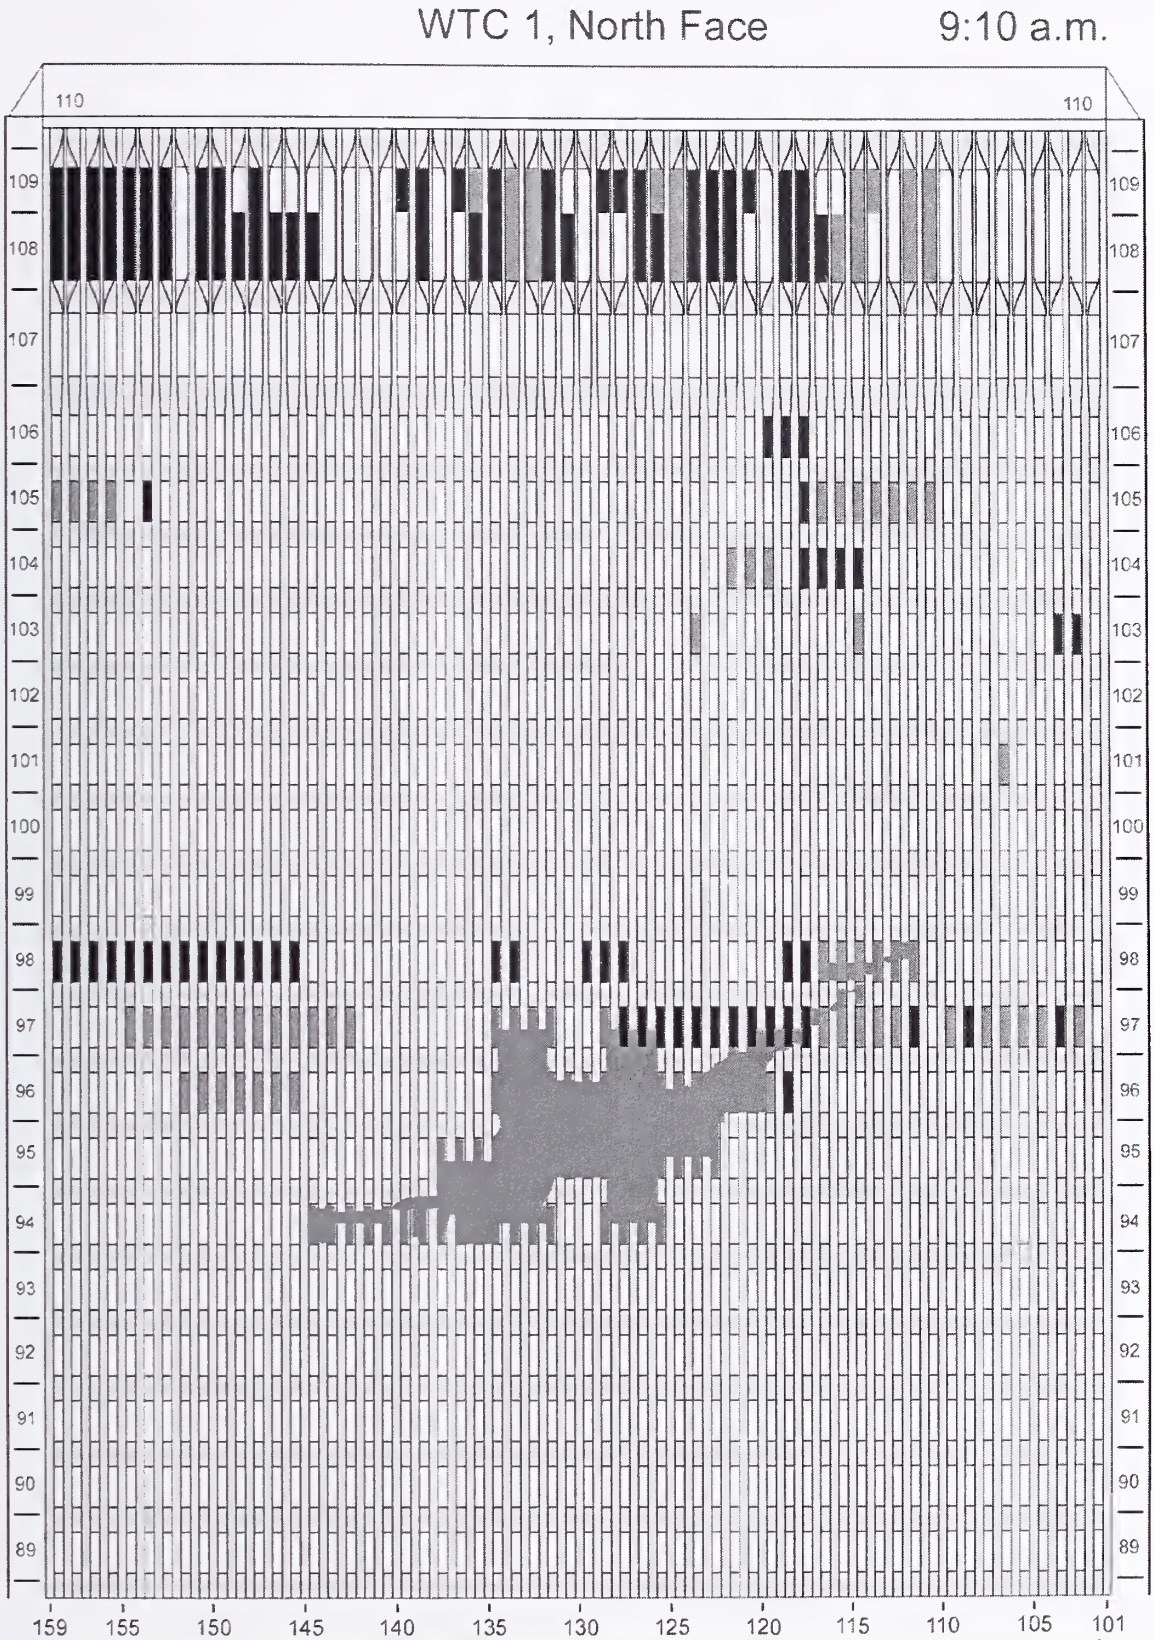
Figure C-22. Diagram of the north face of WTC 1 for floors 89 to 110 at 9:10 a.m. showing windows where smoke was observed and those that were hidden from view.

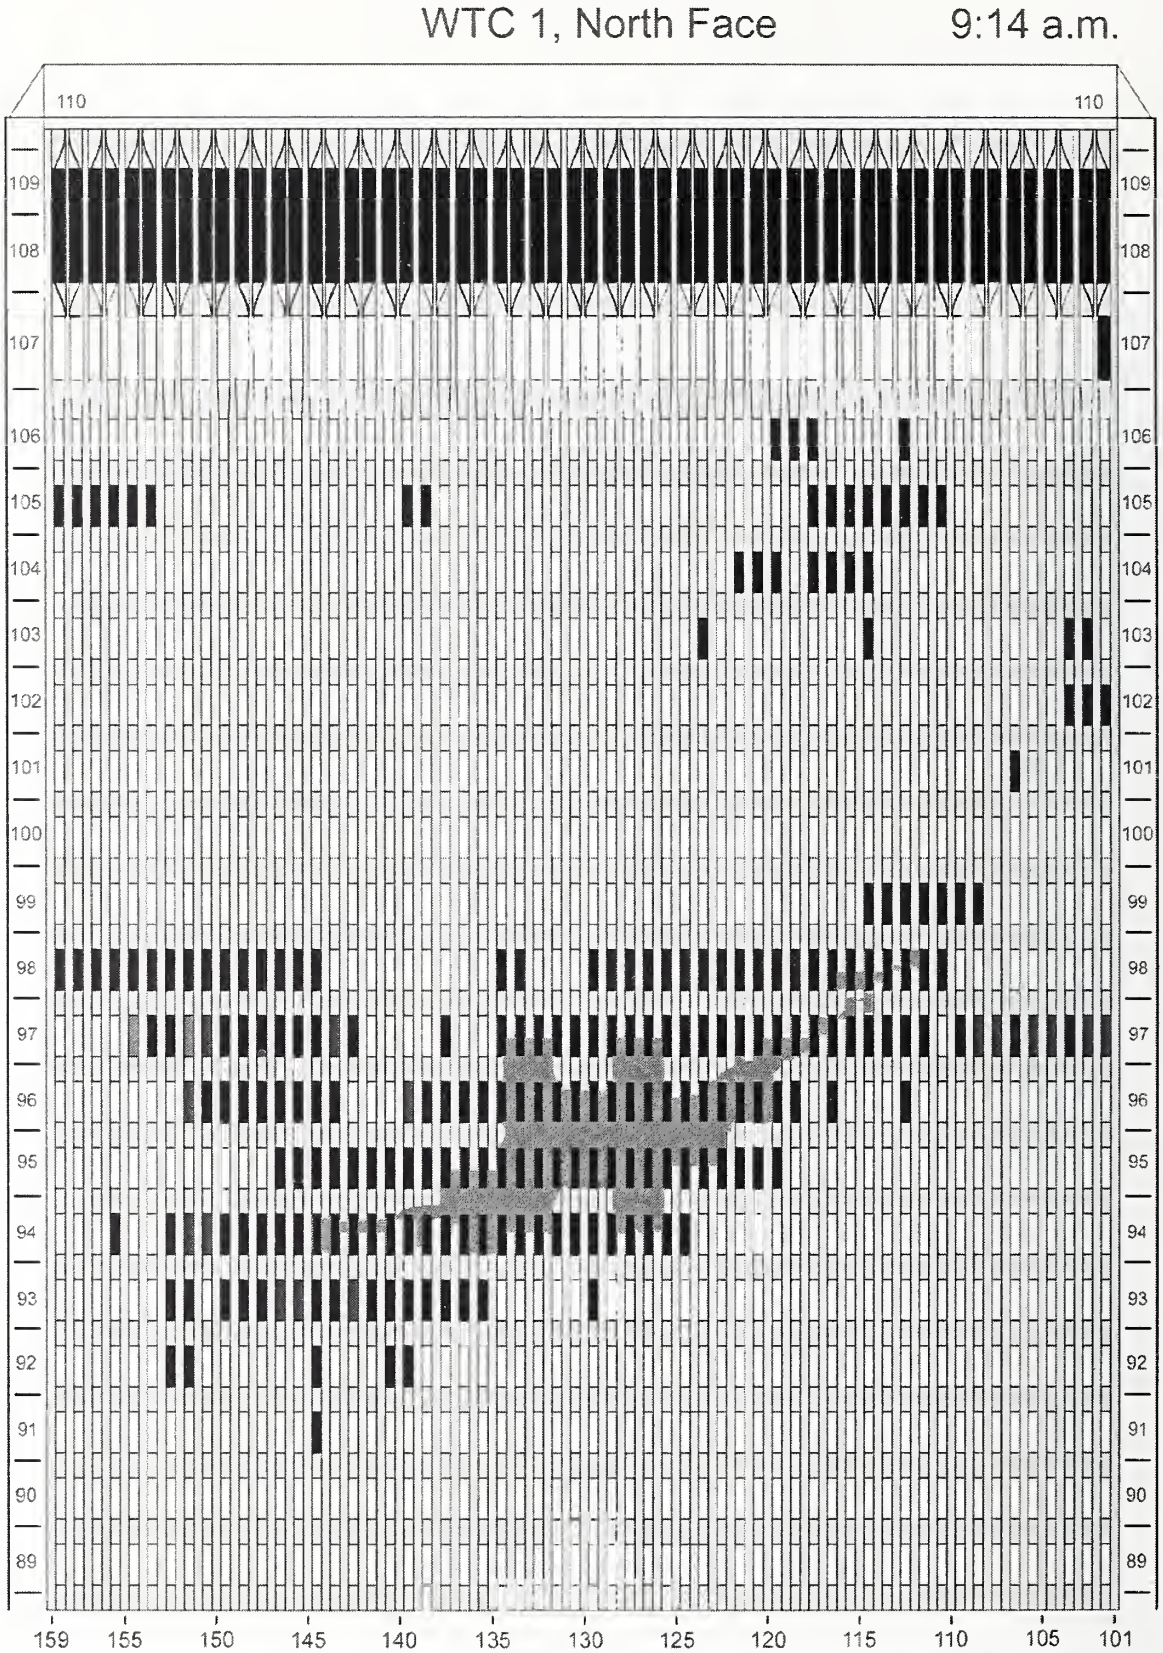
Figure C-23. Diagram of the north face of WTC 1 for floors 89 to 110 at 9:14 a.m. showing the condition of windows and locations of fires.

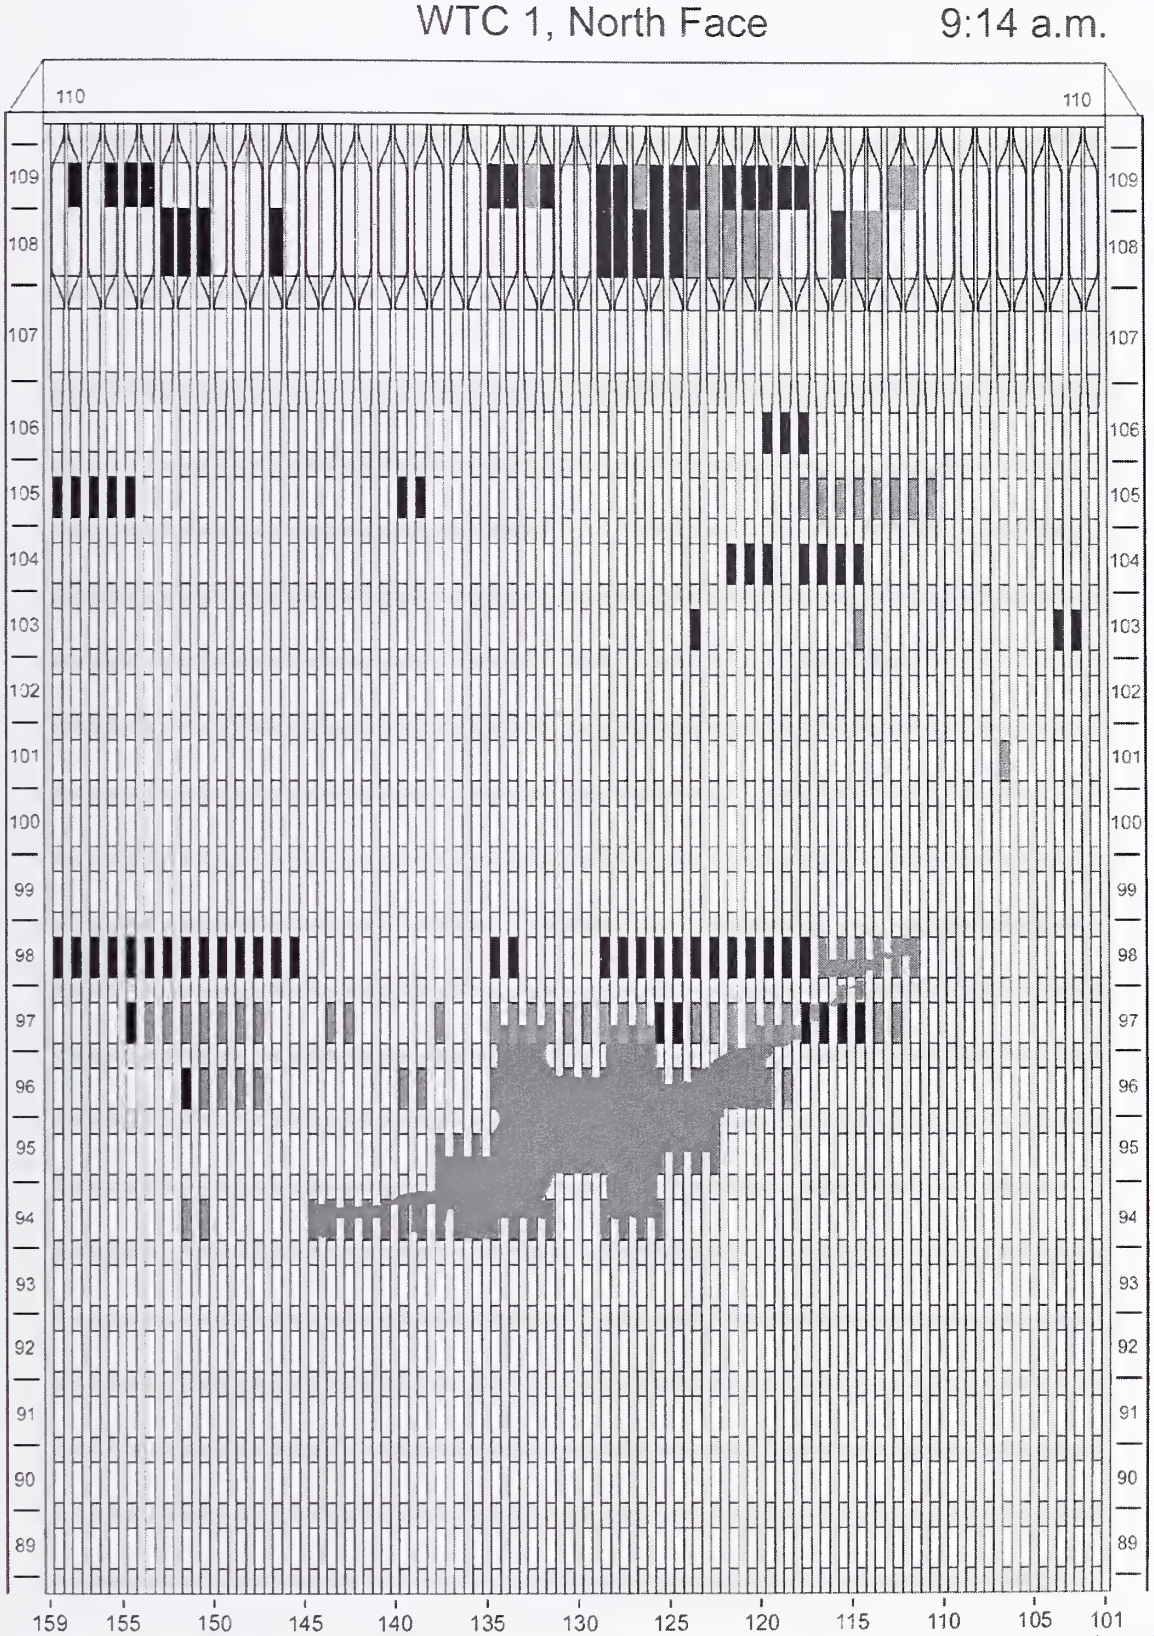
Figure C-24. Diagram of the north face of WTC 1 for floors 89 to 110 at 9:14 a.m. showing windows where smoke was observed and those that were hidden from view.

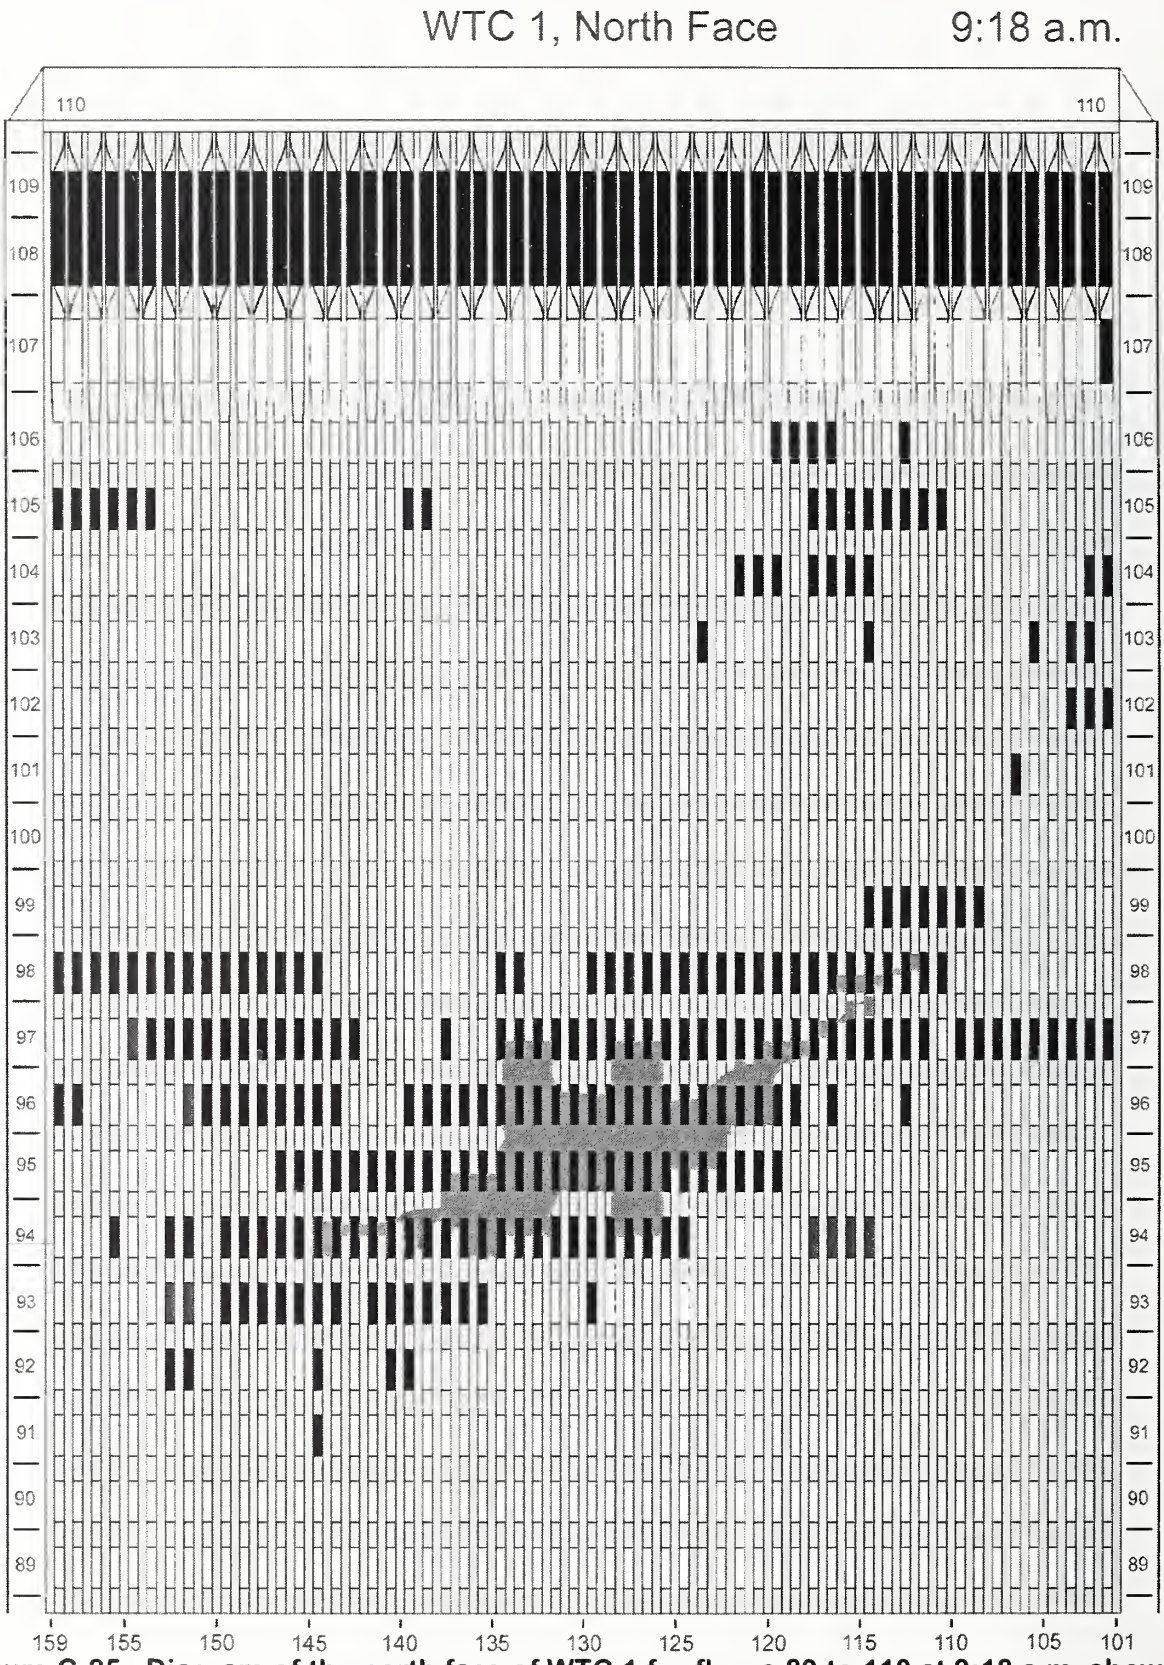
Figure C-25. Diagram of the north face of WTC 1 for floors 89 to 110 at 9:18 a.m. showing the condition of windows and locations of fires.

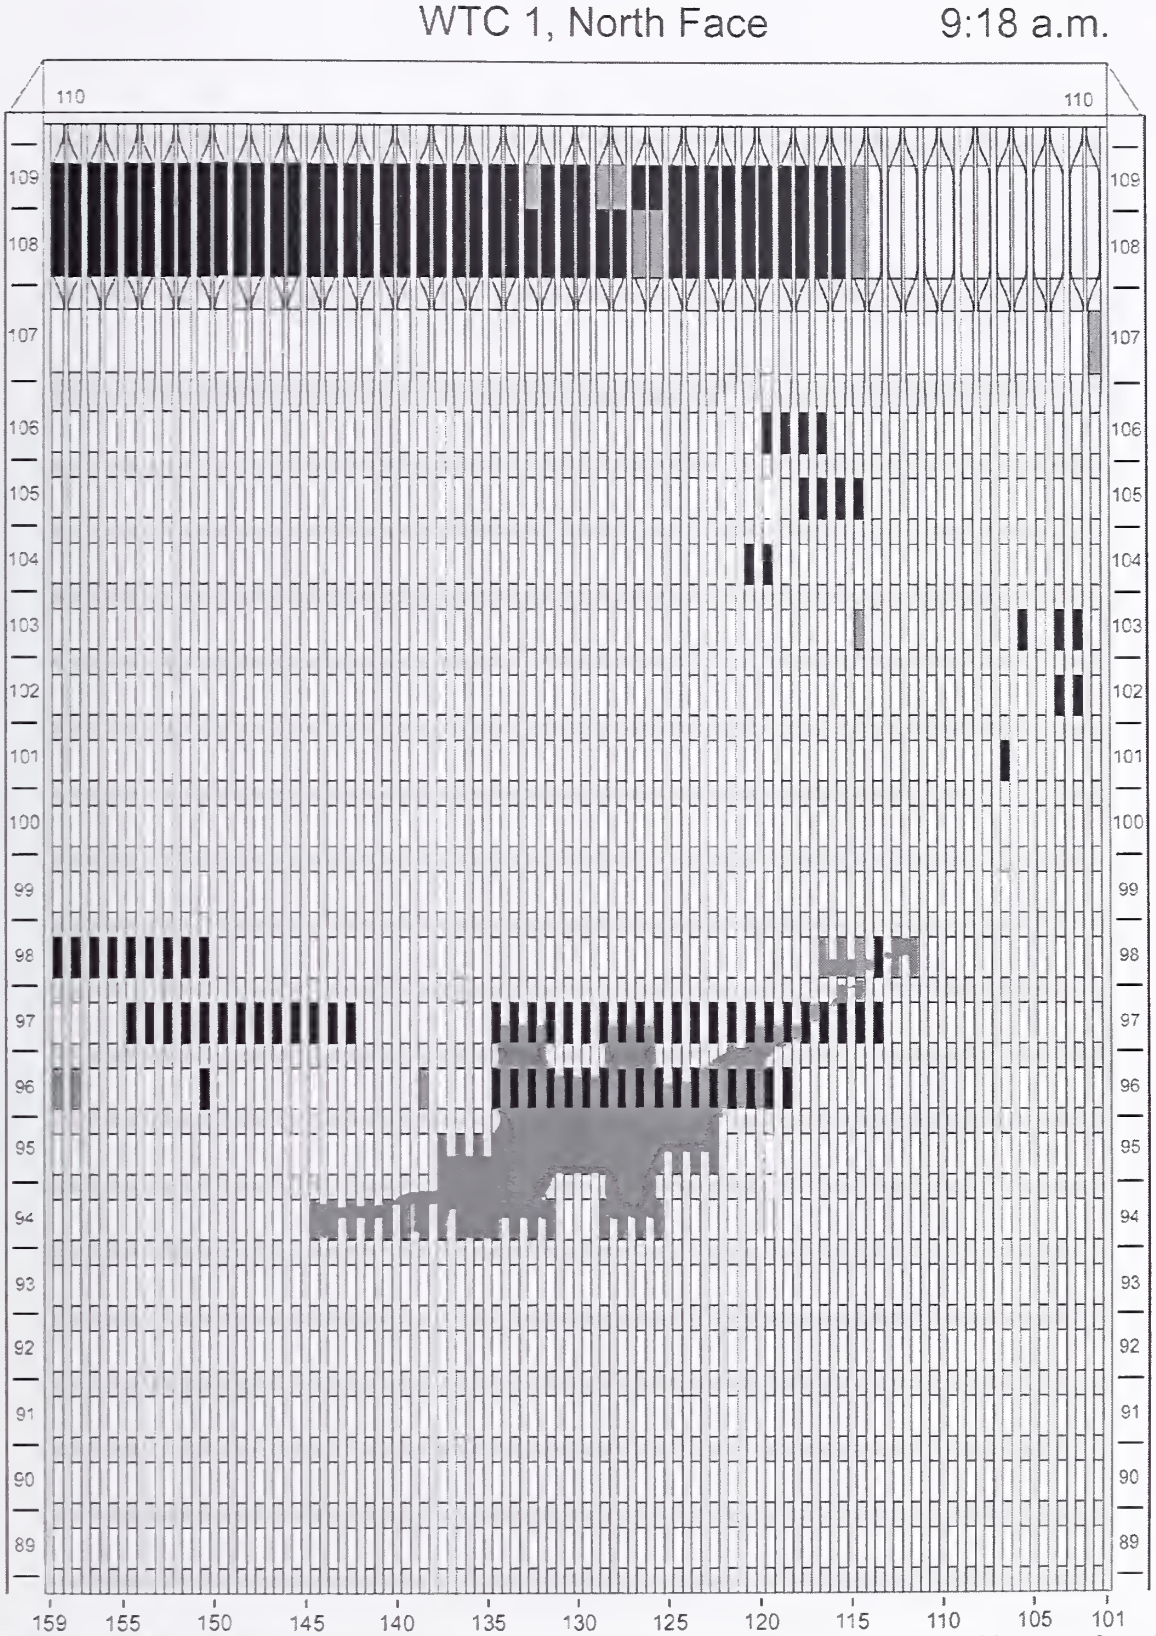
Figure C-26. Diagram of the north face of WTC 1 for floors 89 to 110 at 9:18 a.m. showing windows where smoke was observed and those that were hidden from view.

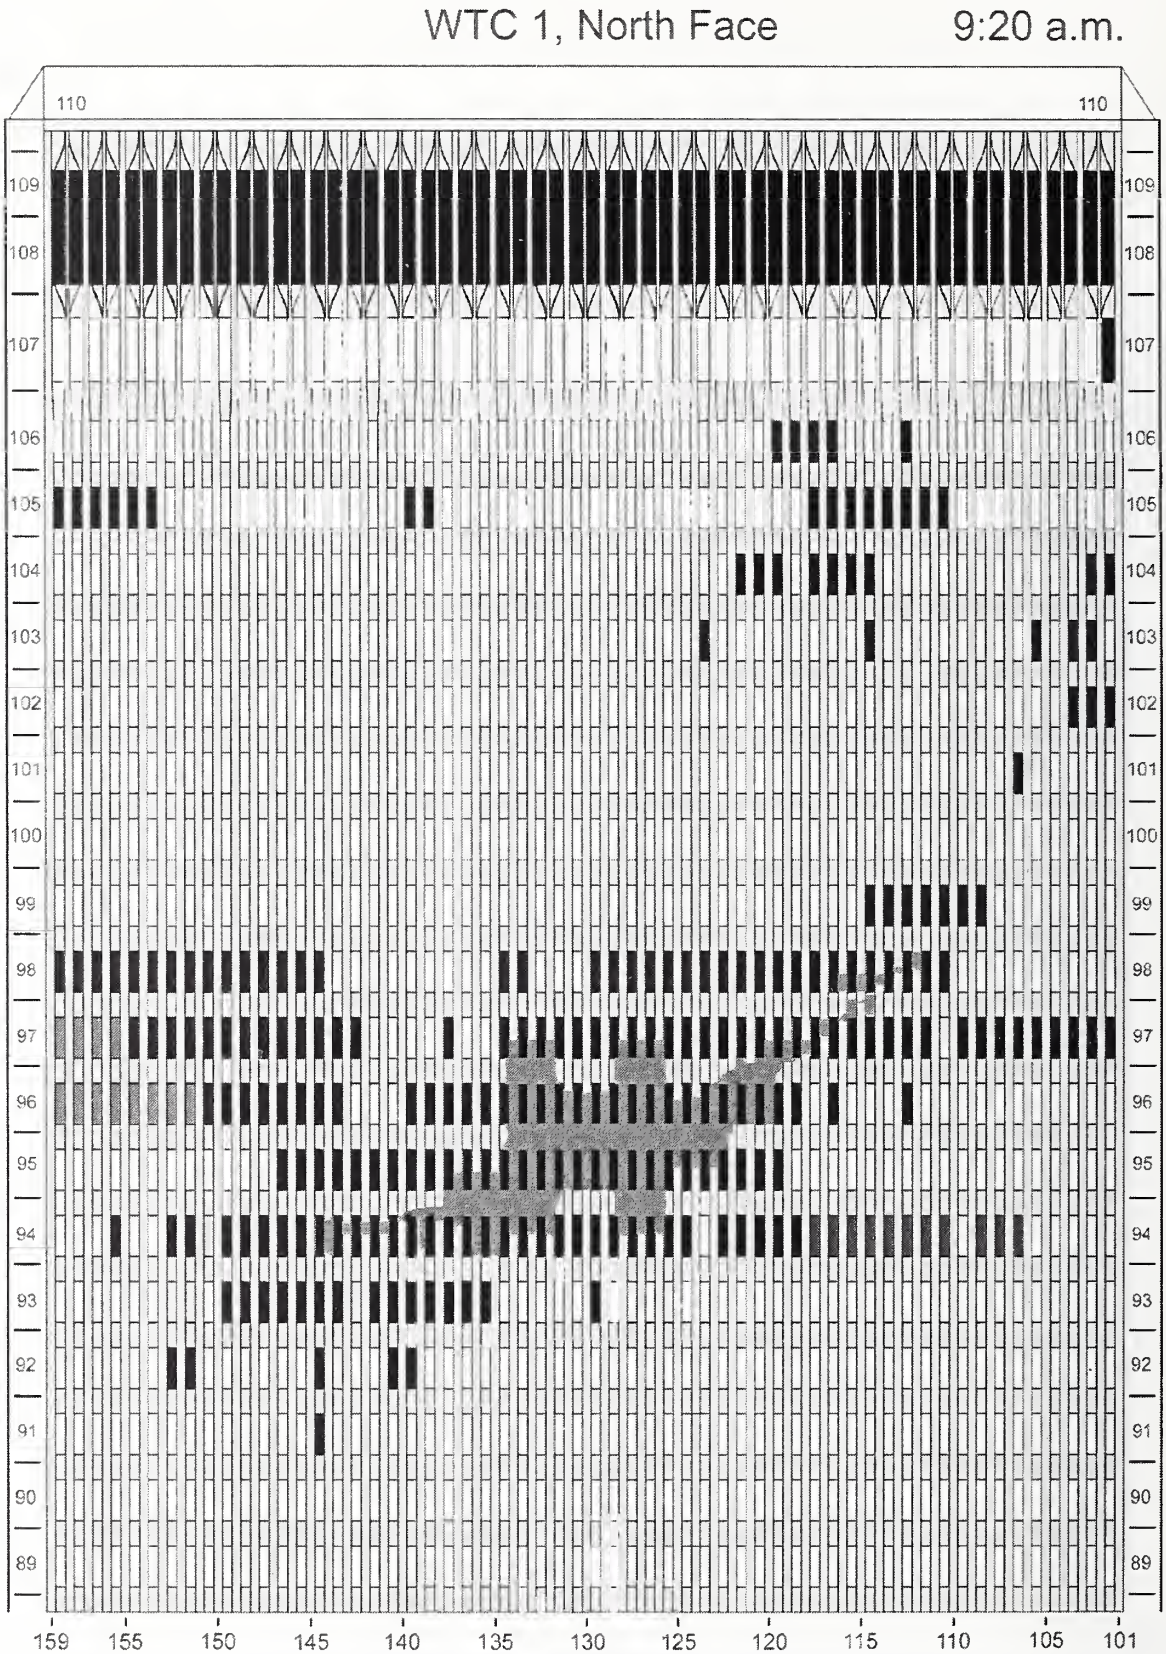
Figure C-27. Diagram of the north face of WTC 1 for floors 89 to 110 at 9:20 a.m. showing the condition of windows and locations of fires.

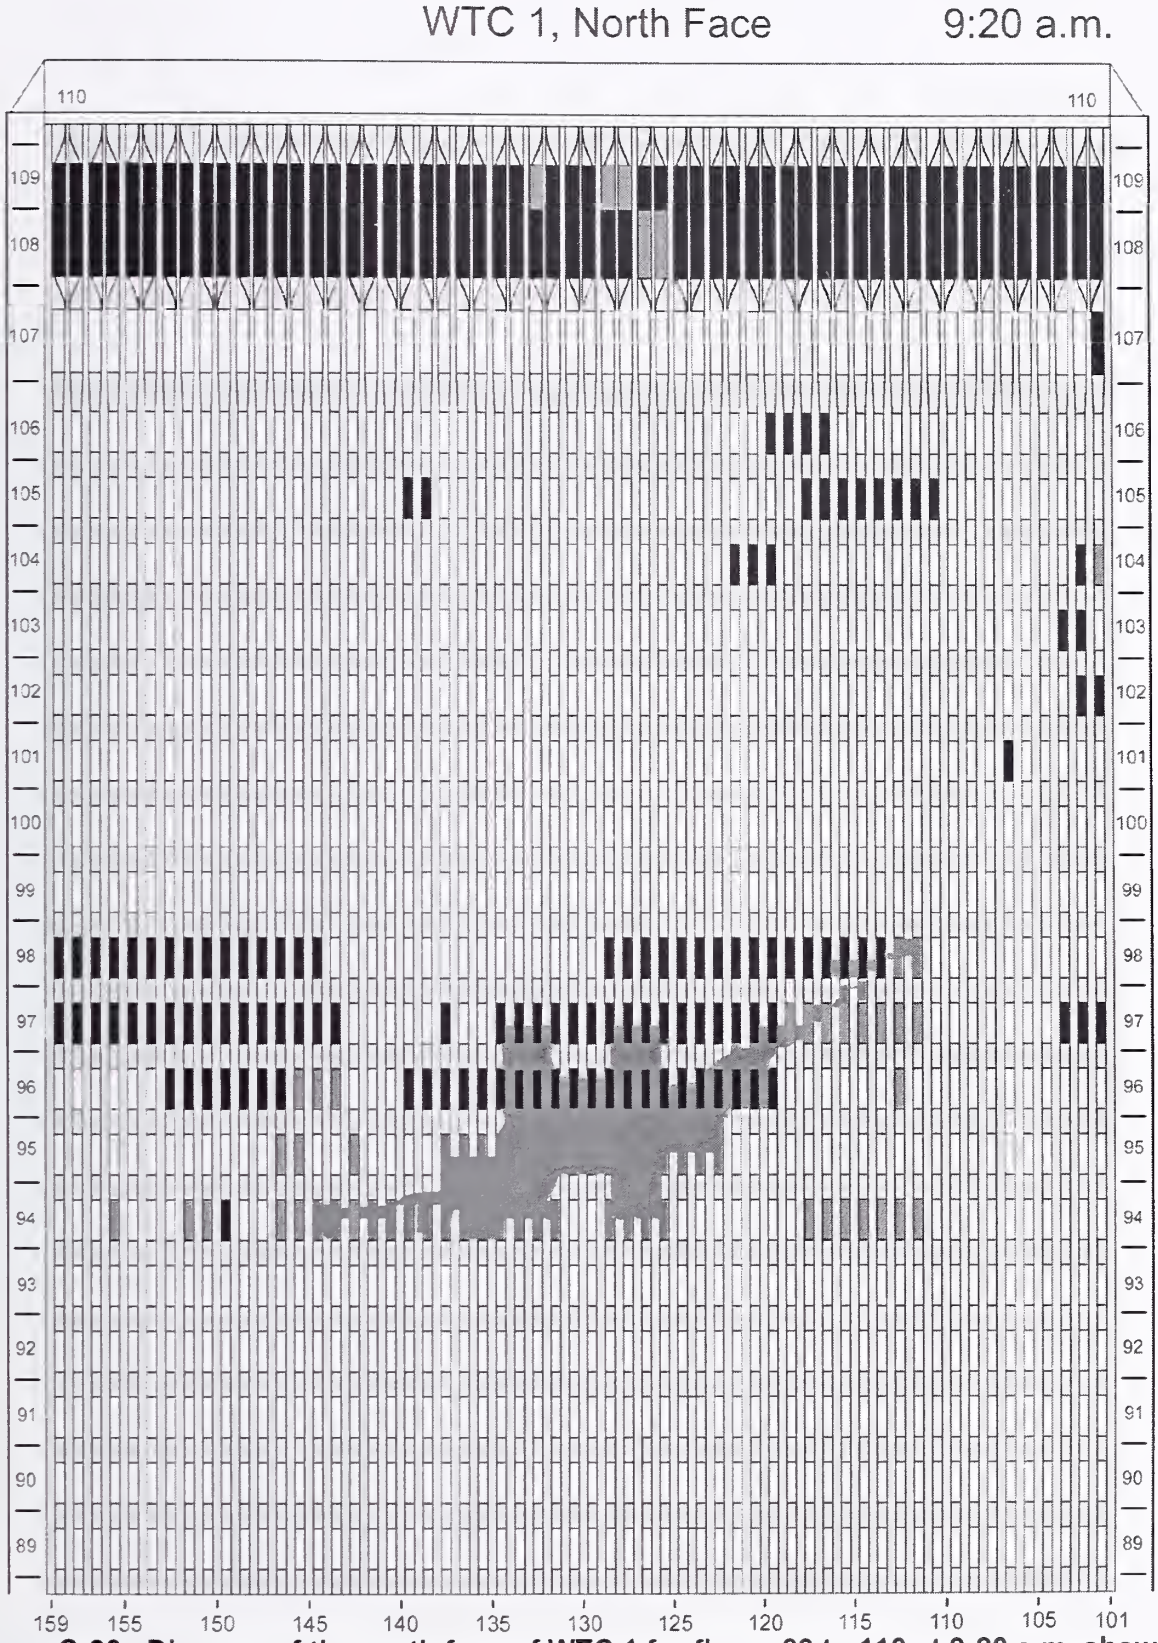
Figure C-28. Diagram of the north face of WTC 1 for floors 89 to 110 at 9:20 a.m. showing windows where smoke was observed and those that were hidden from view.

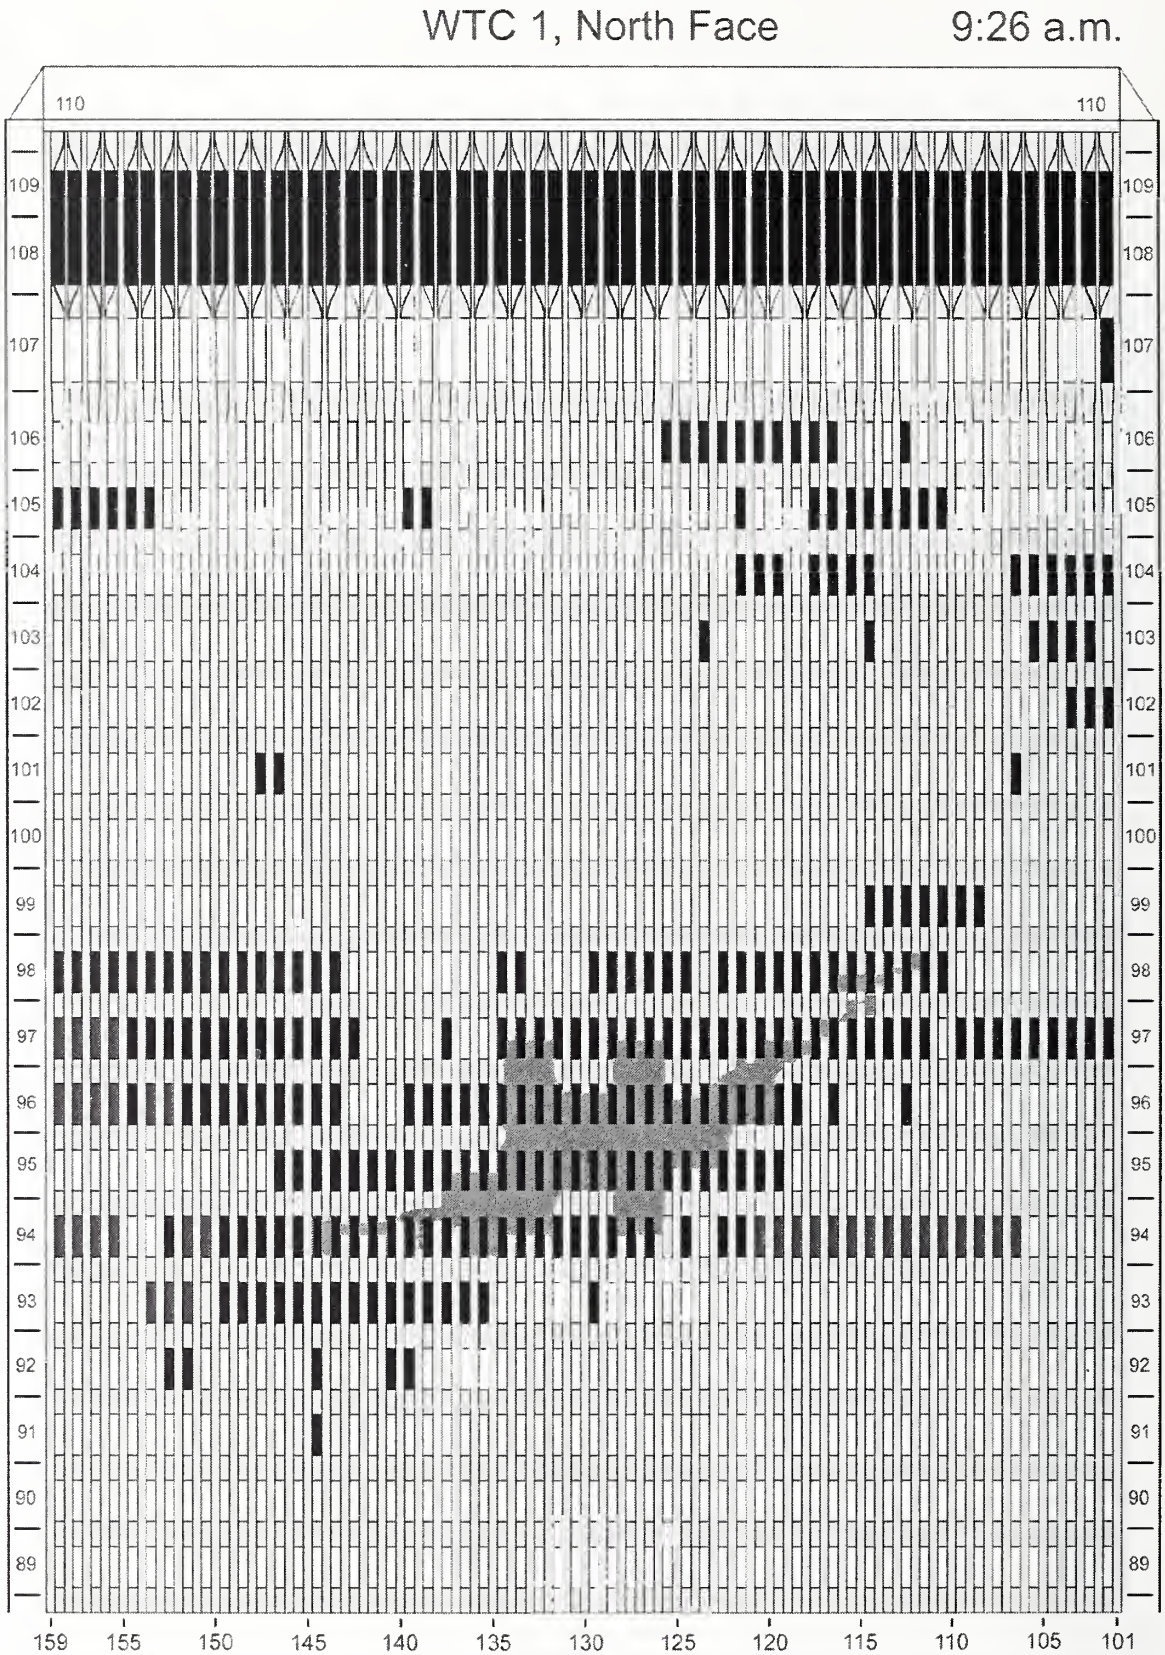
Figure C-29. Diagram of the north face of WTC 1 for floors 89 to 110 at 9:26 a.m. showing the condition of windows and locations of fires.

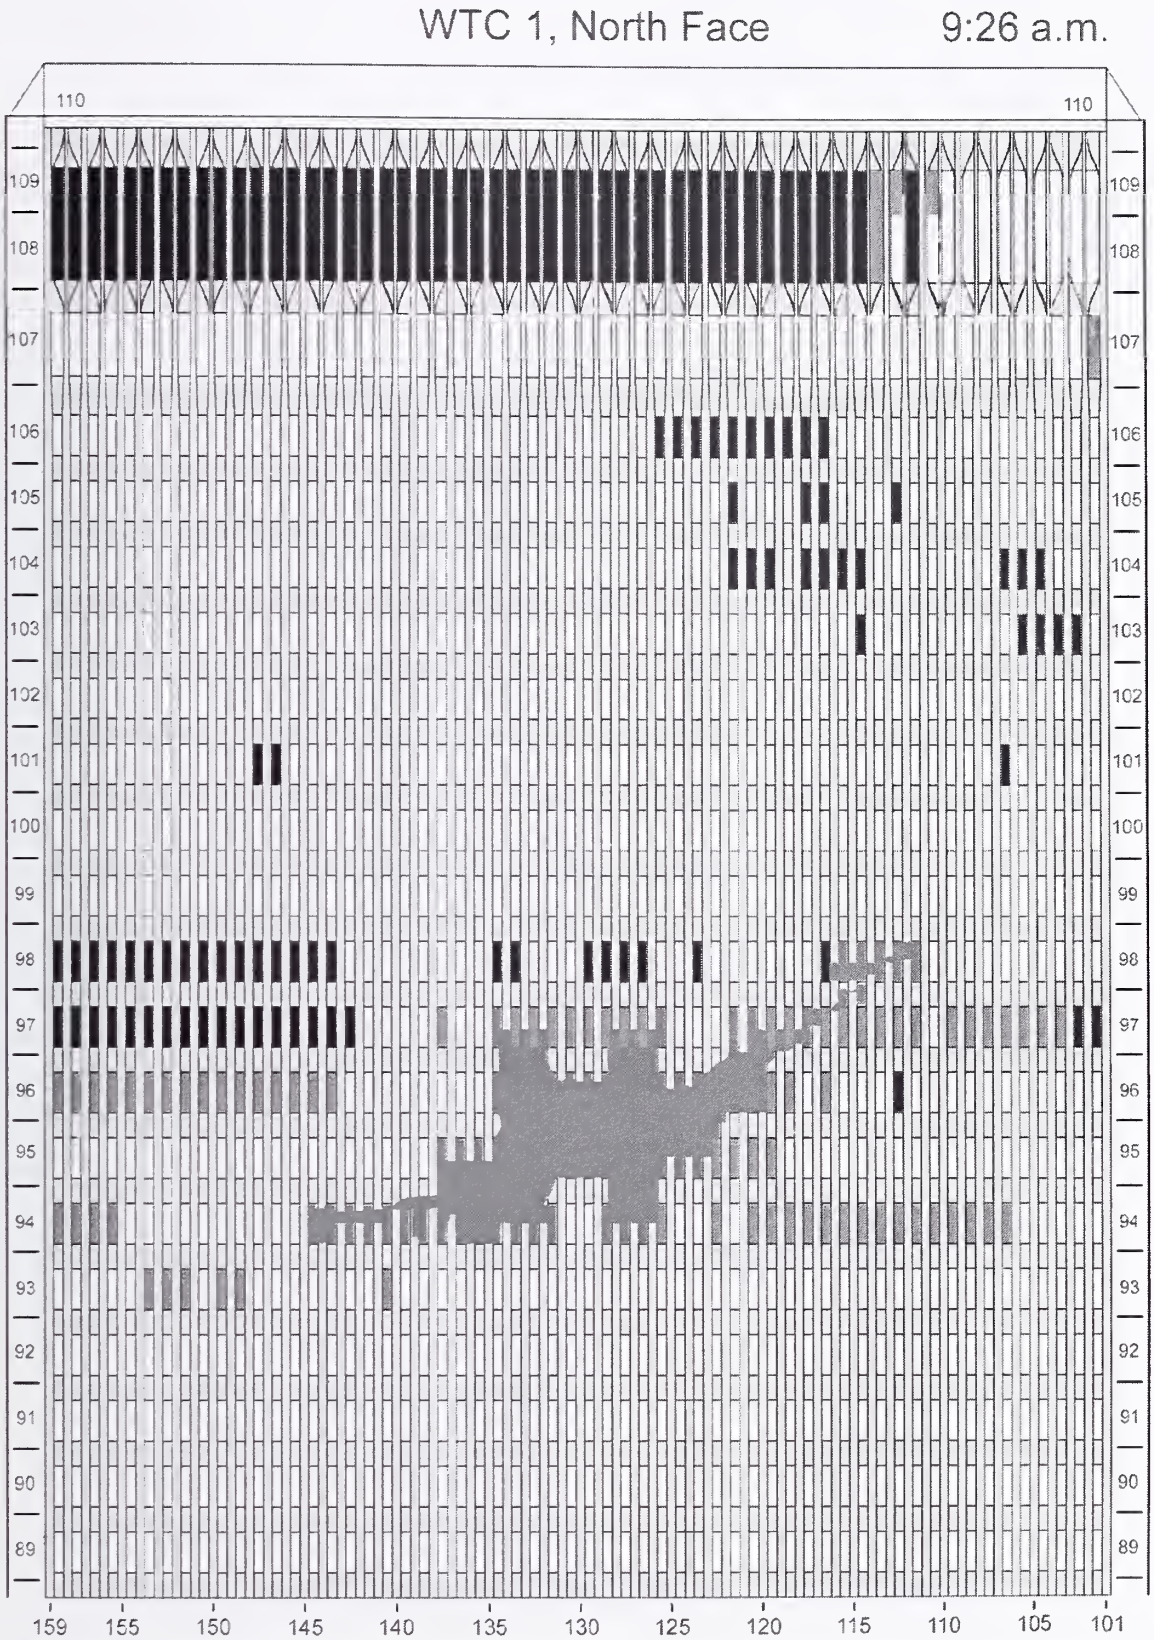
Figure C-30. Diagram of the north face of WTC 1 for floors 89 to 110 at 9:26 a.m. showing windows where smoke was observed and those that were hidden from view.

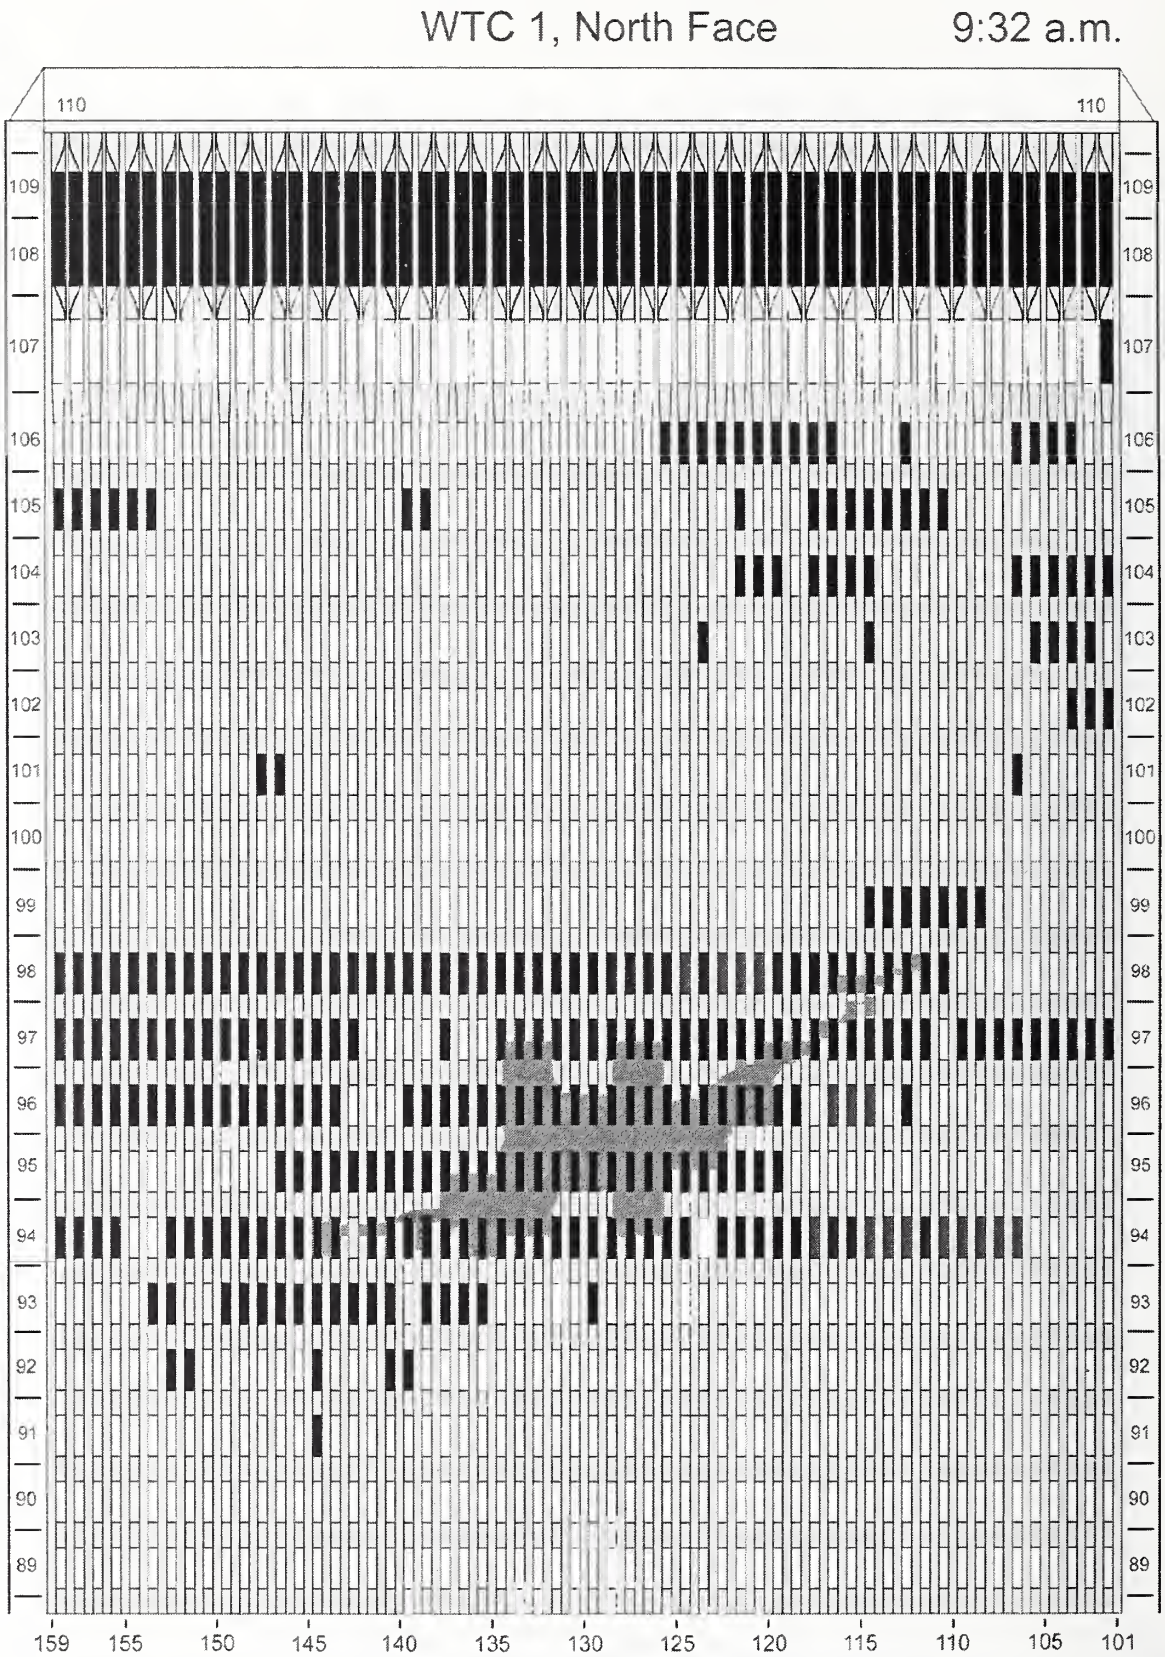
Figure C-31. Diagram of the north face of WTC 1 for floors 89 to 110 at 9:32 a.m. showing the condition of windows and locations of fires.

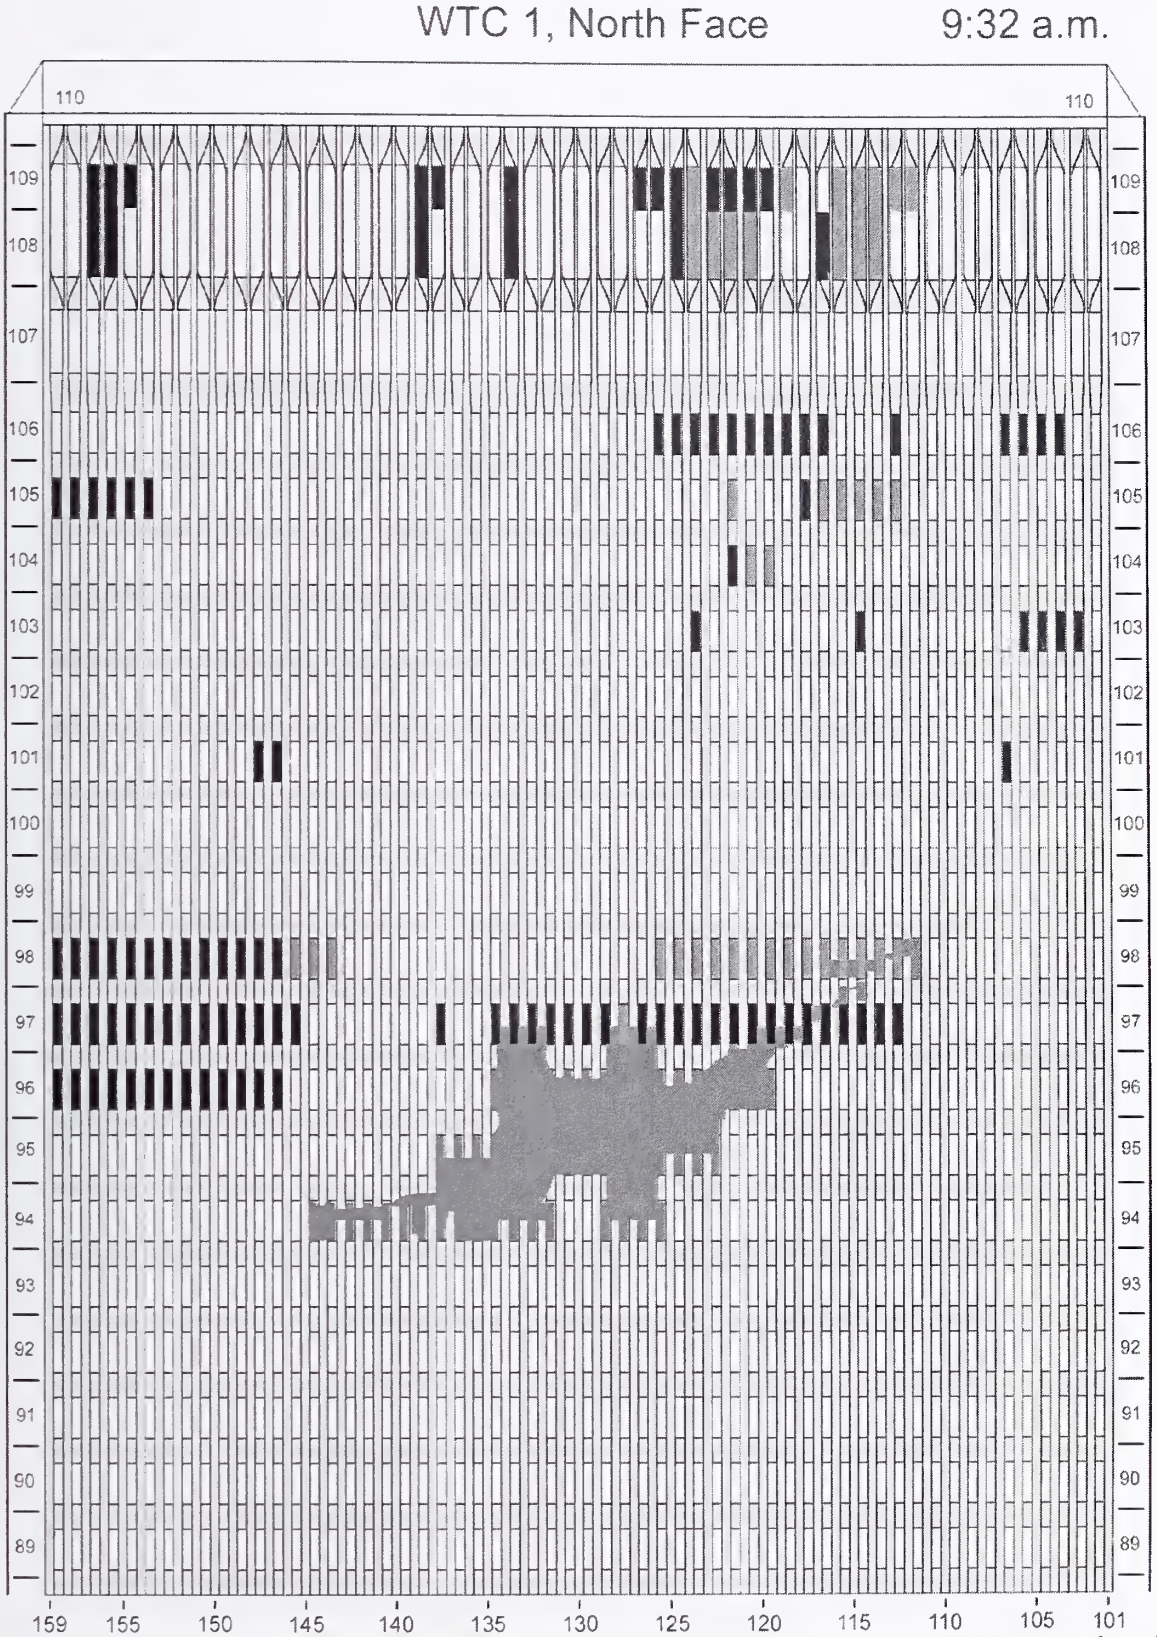
Figure C-32. Diagram of the north face of WTC 1 for floors 89 to 110 at 9:32 a.m. showing windows where smoke was observed and those that were hidden from view.
